TURN AND BANK

November - December 2013

The investigation into the crash of Zenith 601 C-GYNX has been completed. Peter Whittaker led the team and Rob

ON NOVEMBER 3RD, 2013 Zenair 601 HDS C-GYNX was conducting initial circuits at Delta Heritage Airpark, Delta, British Columbia, Canada (CAK3) after being imported from the USA. The aircraft was powered by a Subaru EA81 engine with a Stratus aircraft conversion. On the third circuit after take-off and upon initial climb out, the engine stopped abruptly at an estimated height of between 150 and 200 feet above ground. The aircraft suffered a very hard landing on the grass runway and bounced into a row of bushes lining the runway. The aircraft was deemed a write-off as the landing gear was destroyed and the fuselage both behind and forward of the cabin was crushed. The pilot was alive and conscious at the scene and sustained non-life threatening injuries. After the pilot was safely removed from the aircraft, the structure was secured by turning off all electrical and fuel systems. The aircraft was moved into a hangar where it was covered until a later investigation could take place.

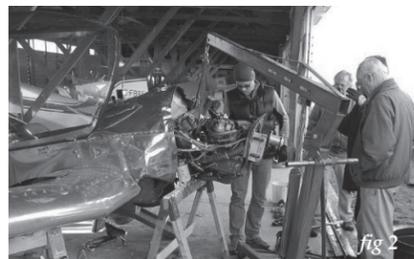
Figure 2: The aircraft was raised and blocked to put the engine at a suitable height for inspection and allow a tray to be placed underneath to catch oil and any loose parts. Figure 3: The spark plugs each have normal gaps and have not been deformed by piston head impact. Figure 4: Valves are undamaged and moved normally when the engine crank was rotated. Figure 5: The steel gear at the end of the distributor drive shaft is covered

The aircraft, a Zenith 601 HDS, was prepared for inspection by raising it with an engine hoist, placing blocks under the main gear attachment points and sawhorses under the wing spars (Fig.2). This allowed for cleaning and removal of leaves and debris from underneath.

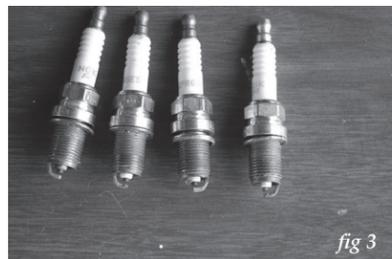
3. Spark plugs were removed and all had normal gaps (Fig.3)

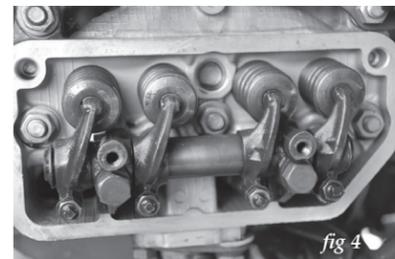
4. Left and right valve rocker covers were removed and no sign of damage was apparent, all valves operated normally when the crank was rotated (Fig.4) and all pistons moved

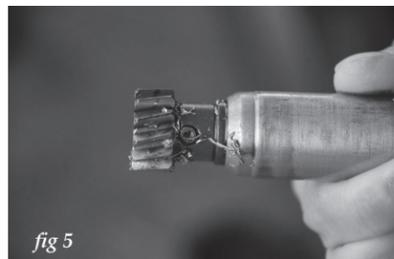
with aluminum shavings from the aluminum drive gear with which it meshed on the engine. Figure 6: The distributor housing and shaft assembly. The inside of the distributor housing is scratched which could result from damage caused by the metal fragments. Figure 7: Distributor shaft with brass and other metal fragments found when the distributor assembly was taken apart. The rotor is also damaged.

11. The distributor was removed and the steel drive shaft end gear was found to be covered in aluminum shavings (Fig.5), the engine could be turned freely in both directions after removal of the distributor

12. A borescope examination of the aluminum engine drive gear to the distributor shaft gear showed that all aluminum teeth had been stripped off of the gear

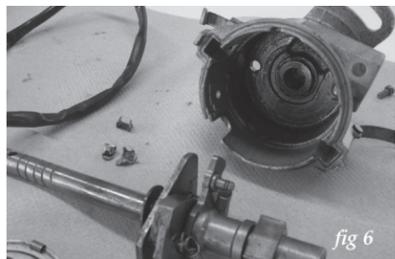
13. The distributor was taken apart, the inside of the housing was found to be damaged (Fig.6) and several metallic fragments, including a brass fragment (the original rotor tip), were found jammed between the shaft (Fig.7) and the housing

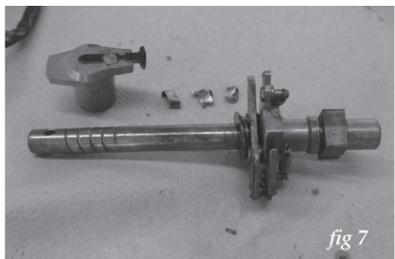
the missing brass piece from the rotor eventually worked its way between the distributor shaft and housing. A prior hard landing and steep climb angle may have caused it to move into a location where it jammed the shaft. The steel gear at the end of the seized shaft subsequently stripped

the gear teeth off of the soft aluminum drive gear mounted at the engine. Since the original rotor tip was loose enough to fall off, it was concluded that it had come into contact with the inside of the distributor cap. It was concluded that the rotor tip had come into contact with something hard enough to jar it loose to the point that it fell off when the distributor cap and housing were removed for the fuel flow test. A possible cause would be if the cap had, at some point, been installed out of alignment. The rotor tip could then have contacted the inside of the cap and become loosened.

The aircraft was flying normally during post import test flights. Several engine components were serviced prior to the test flight circuits including the distributor. Brass and other metallic fragments were found jammed between the distributor housing and the shaft. These jammed fragments stopped the shaft and the attached steel gear. This action then stripped the teeth off of the aluminum drive gear at the engine with which it was engaged.

The lesson learned from this incident would be that all aircraft parts, bits and pieces lost during maintenance procedures involving the engine or any other moving parts such as control linkages, hinges, cables and control surfaces, must be accounted for prior to flying the aircraft.
