TURN AND BANK

November - December 2013

The investigation into the crash of Zenith 601 C-GYNX has been completed. Peter Whittaker led the team and Rob

ON NOVEMBER 3RD, 2013 Zenair 601 HDS C-GYNX was conducting initial circuits at Delta Heritage Airpark, Delta, British Columbia, Canada (CAK3) after being imported from the USA. The aircraft was powered by a Subaru EA81 engine with a Stratus aircraft conversion. On the third circuit after take-off and upon initial climb out, the engine stopped abruptly at an estimated height of between 150 and 200 feet above ground. The aircraft suffered a very hard landing on the grass runway and bounced into a row of bushes lining the runway. The aircraft was deemed a write-off as the landing gear was destroyed and the fuselage both behind and forward of the cabin was crushed. The pilot was alive and conscious at the scene and sustained non-life threatening injuries. After the pilot was safely removed from the aircraft, the structure was secured by turning off all electrical and fuel systems. The aircraft was moved into a hangar where it was covered until a later investigation could take place.

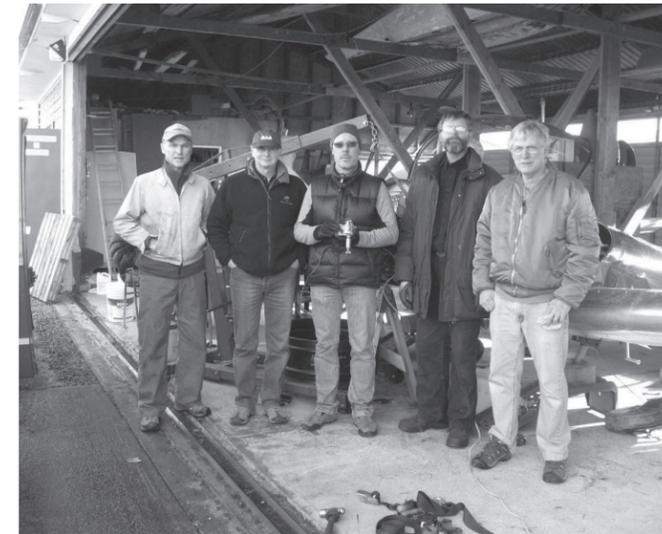
Figure 8. Accident investigation team, left to right: John Macready, Peter Whittaker, Rob Prior (holding distributor), Gerard Van Dijk and Dave Rose. John de Visser and Andy Pearson were unavailable at the time of the photograph. Gerard Van Dijk and Andy Pearson dismantled the distributor. Bob Cutting, a former member of Chapter 85 was also in attendance for the disassembly process.
